Building an EDGE system to the VEBIC laboratories

School of Technology and Innovations
Master's Thesis
Energy Technology

Vaasa 2024

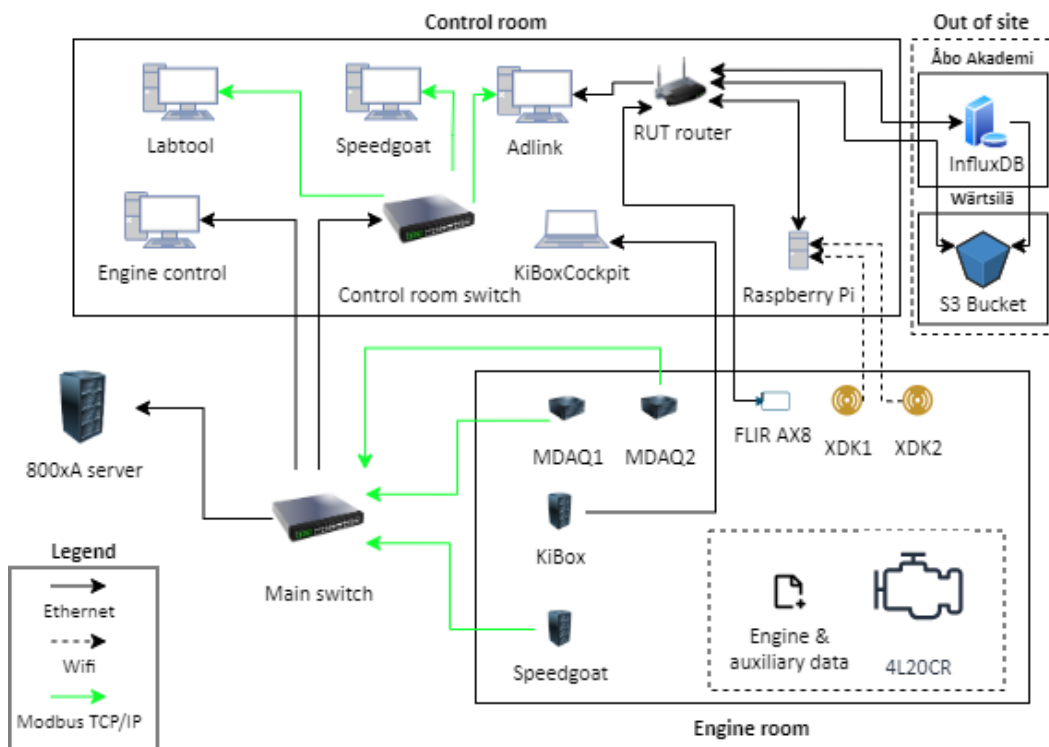
Figure 1. Signal dependencies in the laboratory (legacy parts adapted from Protaccon 2019).

For research and operational purposes, the engine requires different control and measurement systems. These are operated in the control room of the engine laboratory. The connections and their type are given in Figure 1. A majority of the existing system uses the Modbus TCP/IP protocol, a very common automation control protocol, for signals and commands. For new connections, ethernet connectors and wireless solutions were applied.

The thermal camera was connected to the Adlink through the RUT router (Figure 1). It was completely controlled through a web-interface and saved the recorded files to Adlink. It was attached to a rail and used for two different exhaust gas leak detection set ups.

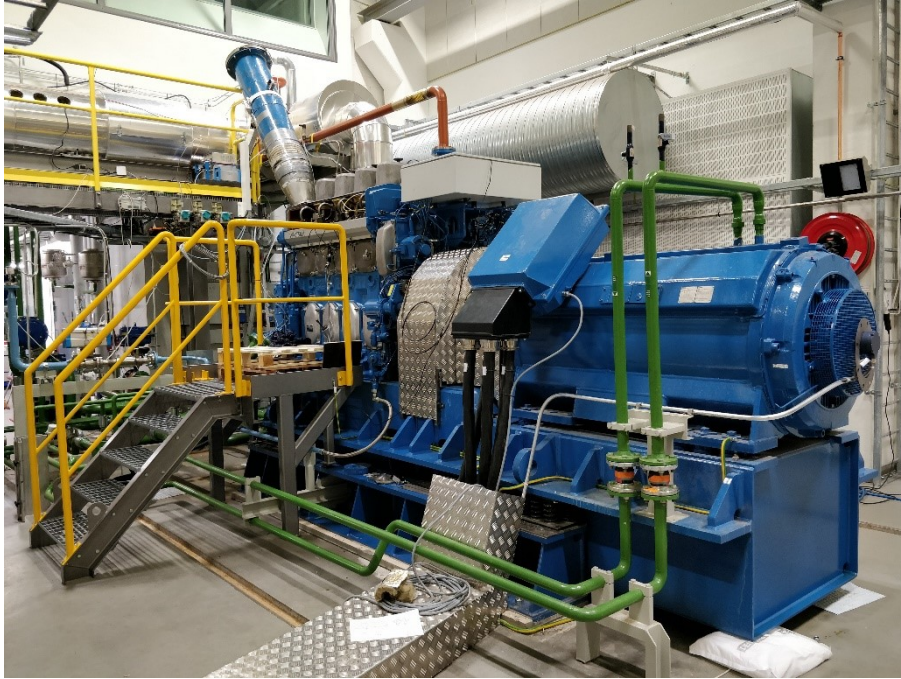
Figure 2. The Wärtsilä 4L20CR research engine.

The engine requires different auxiliary systems around it to ensure reliable operation. Data from these auxiliary systems is widely available and accessible in the control room. In addition, new sensors have been added to capture the vibrations caused by engine operation and a thermal camera to detect possible exhaust gas leakages. An image of the 4L20CR engine in the VEBIC laboratories can be seen in Figure 2.

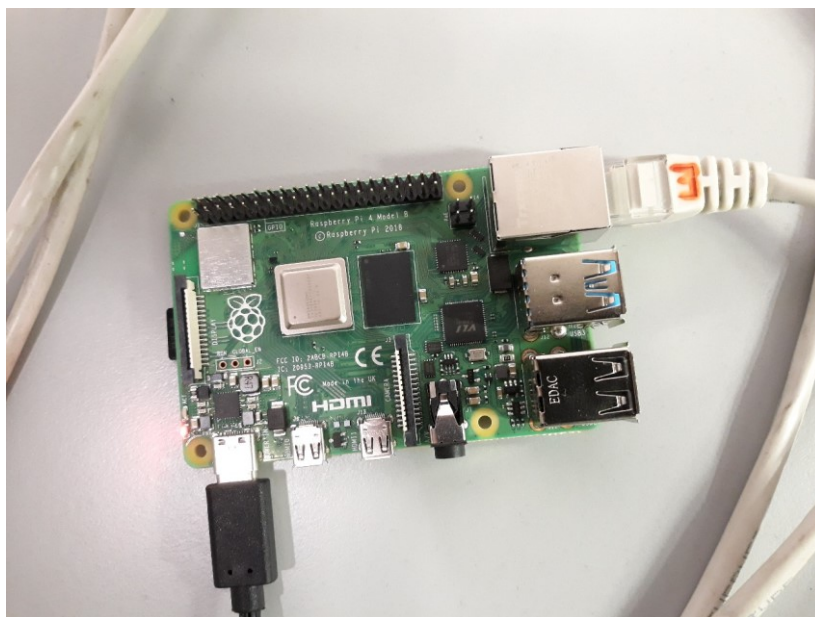
Figure 3. Raspberry Pi 4 Model B in the control room.

The Raspberry Pi was installed in the control room for several reasons. Primarily, its exposed circuit board would require a protective casing if installed close to the engine, where likelihood of oil or other spills is non-negligible. Secondly, the Wi-Fi connection in both XDK sensors and the Raspberry Pi (Figure 3) allowed for easier installation with less cable management. Lastly, in a case where the device stops working, troubleshooting directly from the control room is far more convenient compared to other options.

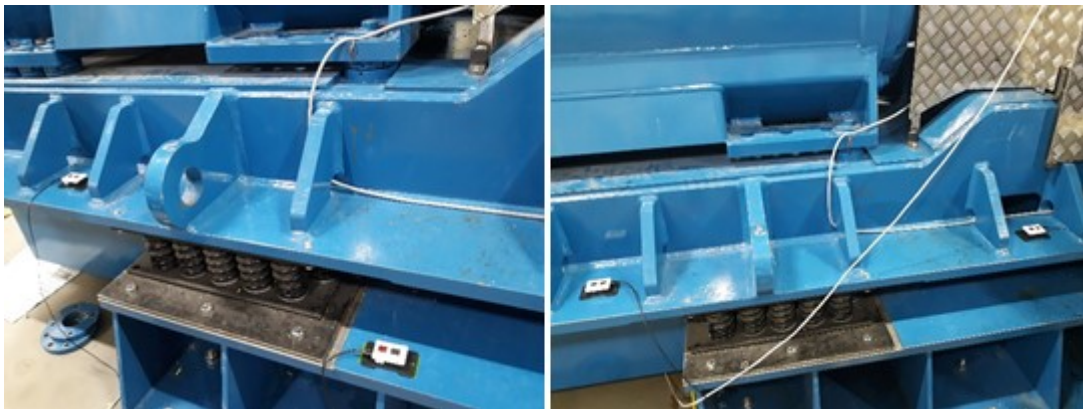
Figure 4. The Bosch XDK110's at their original orientation and position (left) and at their final installation (right).

Due to the fear of leaking oil harming the XDK110 sensors, they were installed next to the generator part of the genset rather than the engine block. At first, the XDK110 closer to the engine (XDK2) was installed below the engine mounts (Figure 4, left). However, soon its permanent position was realized in the same line with XDK1 (Figure 4, right). At the same time, both XDK110's were rotated to face the power port towards control room. They were attached to the genset with a two-sided tape.

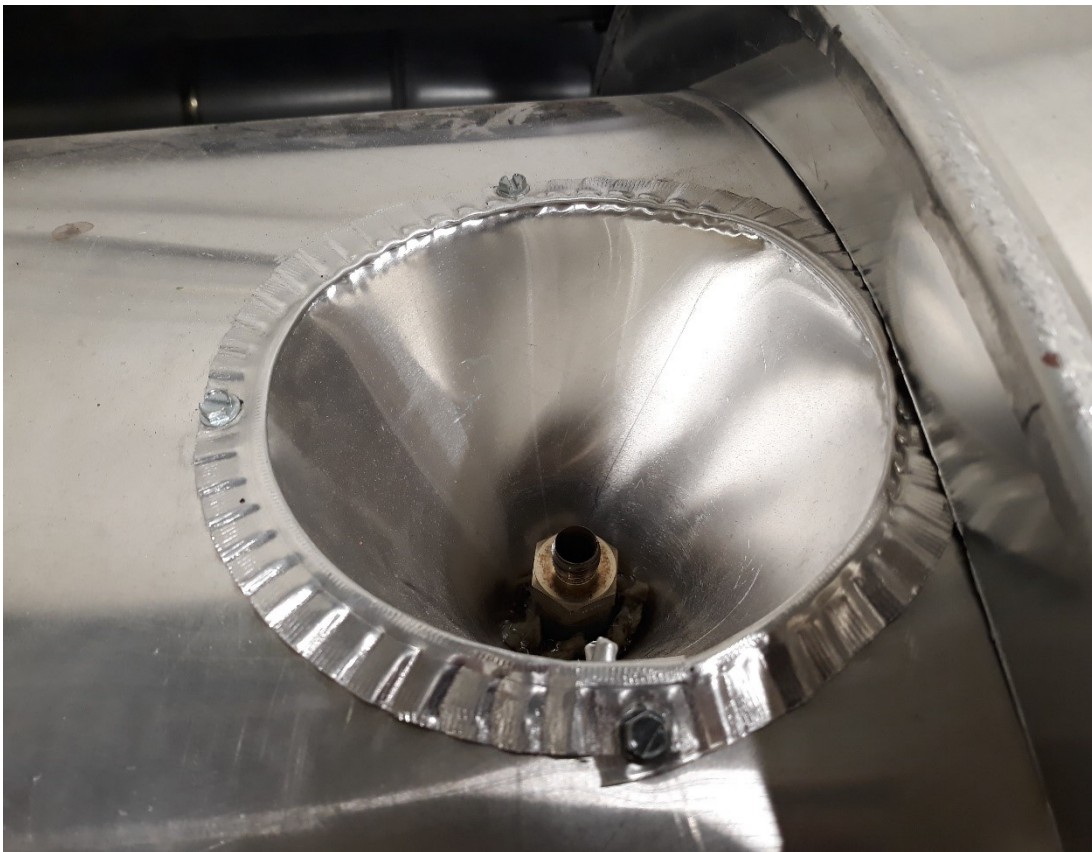
Figure 6. The sample measuring point with the capped nut removed.

To produce an artificial exhaust gas leakage, a capped nut from the measuring point of the exhaust gas sample spot is removed, opening up a free path for the exhaust gas due to slight overpressure in the pipeline (Figure 6). The hypothesis was that as the exhaust gas escapes, it will evidently contact the surrounding edge, heating it up faster compared to the other measuring points. This heat can then be picked up by the thermal camera's FPA sensor, validating the hypothesis.

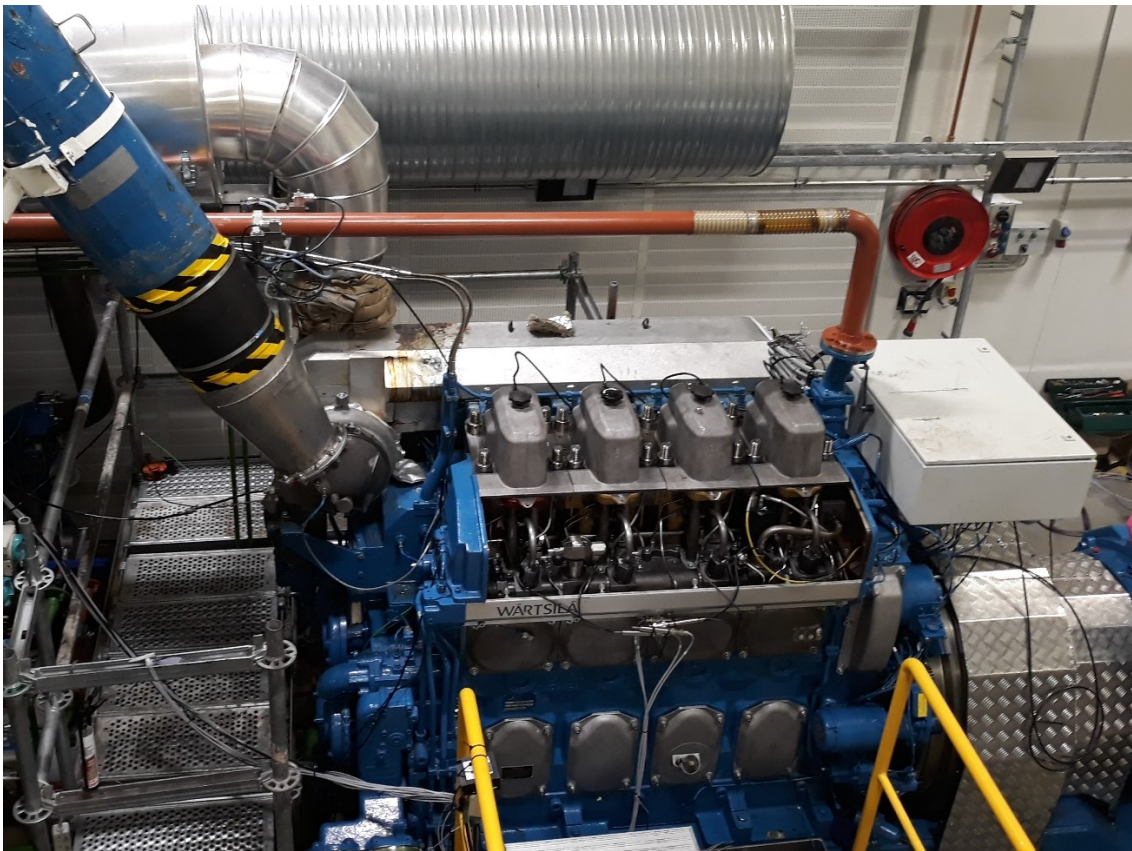
Figure 7. The engine as seen from the thermal camera.

By using the same rail as in the previous experiment, the thermal camera was repositioned and pointed towards the engine (Figure 7). In this experiment, the artificial exhaust gas leakage was produced in the engine's internal exhaust system before the TC. At this stage, the exhaust gas temperature is much higher compared to the sample measuring point, making it easier to detect.

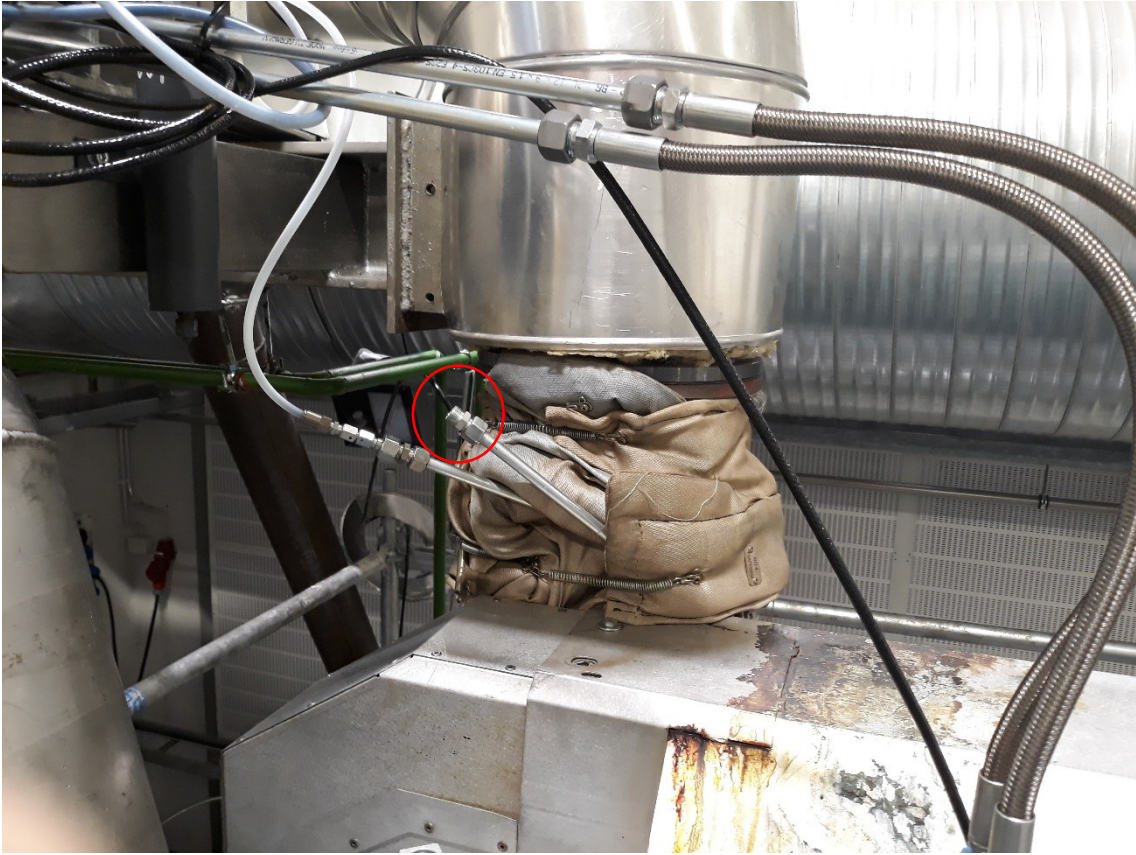
Figure 8. A closeup of the exposed connector to the engine's internal exhaust gas system, circled in red.

The leakage was produced by removing one of the tubes leading to a free-flow pressure sensor (Figure 8). The second pressure sensor's tube was left intact to get a reading on the pressure level before the TC. There are no clear targets for the exhaust gas stream to collide into, but the edges of the nozzle should reach higher temperatures compared to a situation where the tube is attached.

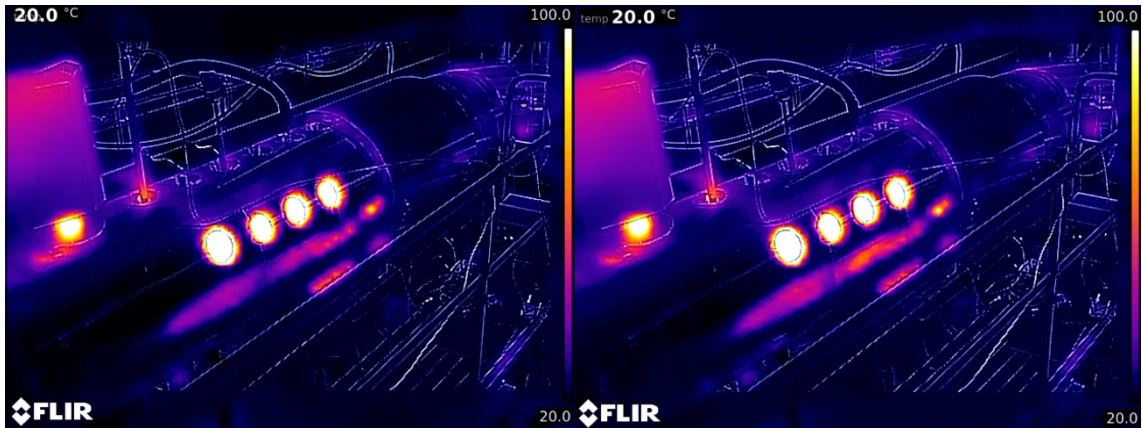
Figure 12. Temperatures 50 minutes after the exhaust gas pipeline had started heating up. No leakage on the left, artificial leakage on the right.

50 minutes past after the first signs of heating up corresponds to timestamps 11:48:49 for the experiment without the leakage and 13:26:54 for the experiment with the artificial leakage. These frames are presented in Figure 12. The results are similar to previous observations: a brighter glow on the side of the exhaust gas pipeline and universally bluer or purple fade on the right frame. No evidence of the artificial leakage can be detected.

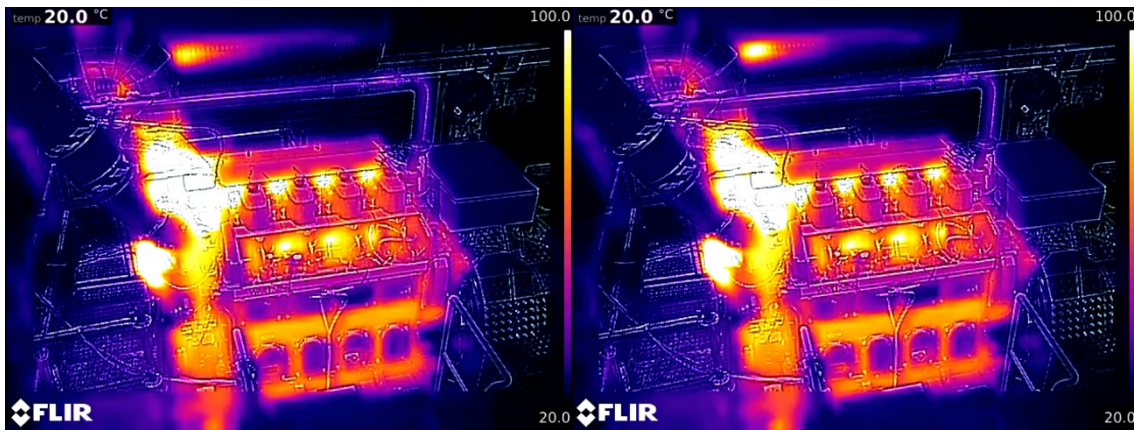
Figure 15. Temperatures 10 minutes after the load command to 100 % in the second experiment. No leakage on the left, artificial leakage on the right.

After full load was achieved and the temperature levels in the engine evened out, a new inspection of the engine was taken (Figure 15). The whole area around the TC is completely bright, indicating temperatures exceeding well above the maximum 100 °C scale. The area around the leakage has a hotter heat profile on the right. Otherwise, the heat profiles of the engine are almost identical in both frames. However, a pipeline in the top of the picture appears hotter in the frame on the right.

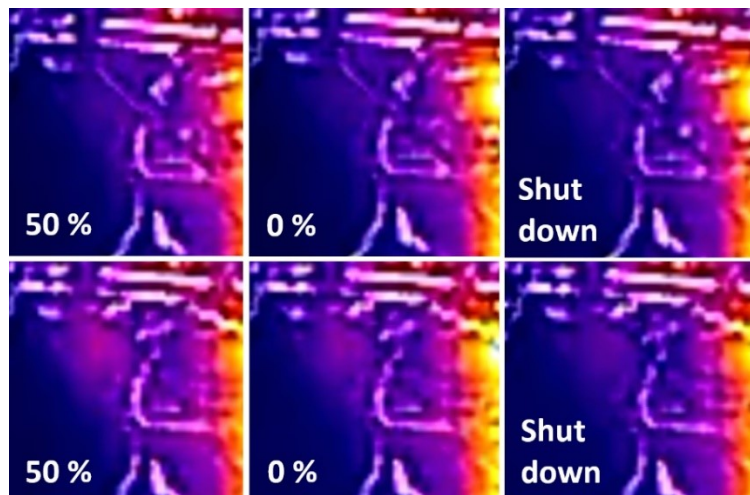
Figure 22. Artificial leakage area at different load points while ramping down in the third experiment. No leakage (first row) versus artificial leakage (second row).

To see how the pattern evolves when load is decreased, new visual data that was absent from the previous experiment is presented. Figure 22 shows how the heat signal with the artificial leakage persists, but diminishes in strength. The heat signal from the area without the artificial leakage has a slight decrease while ramping down.

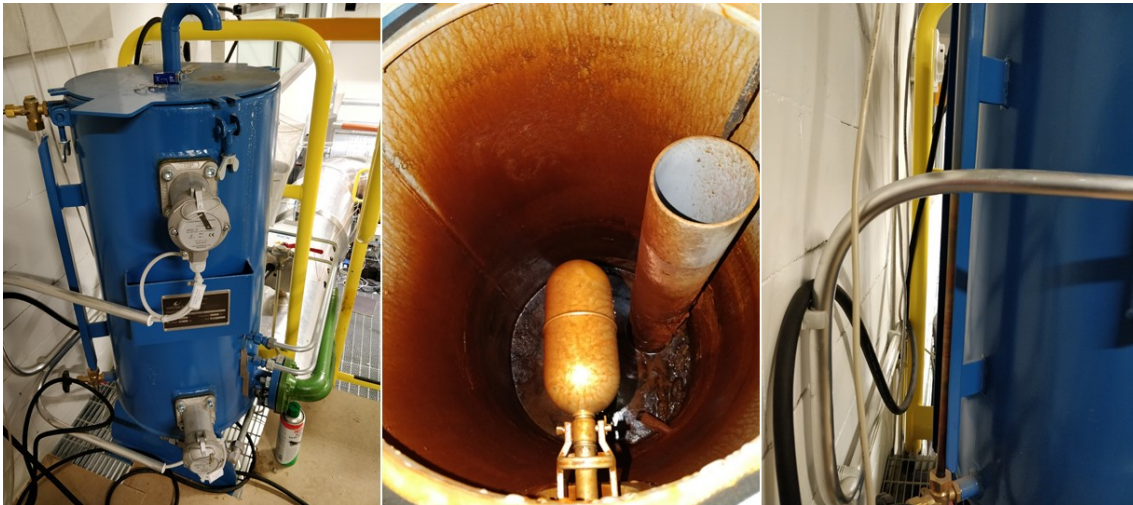
Figure 24. The water expansion tank from outside (left) and inside (middle). The water level can be read from the side (right).

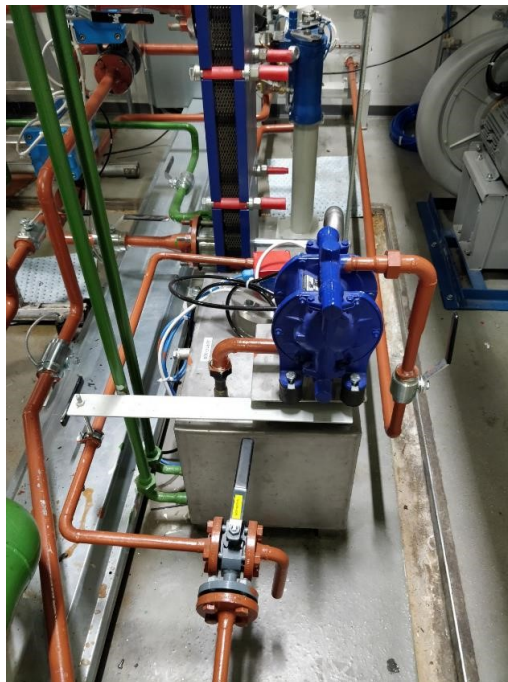
Figure 25. The clean leak fuel tank.

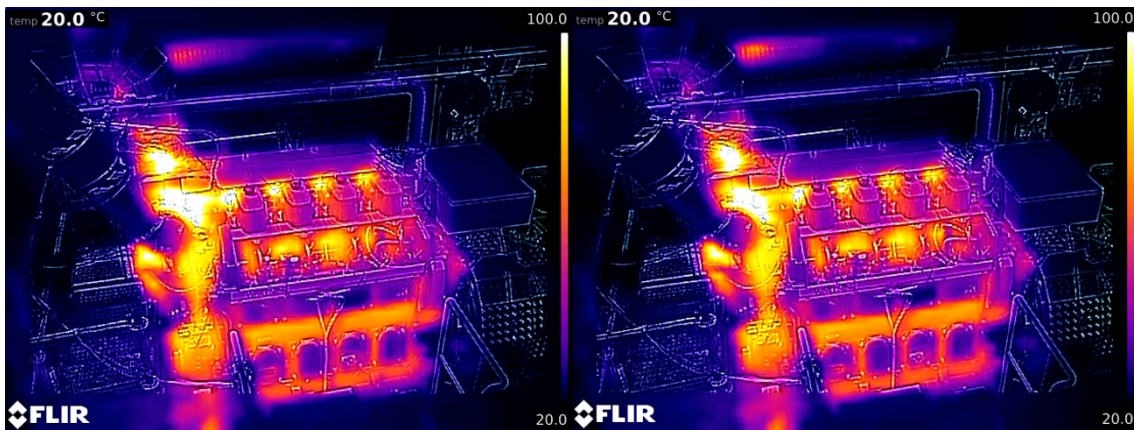
Figure 29. Temperatures at the load command to 75 %. No leakage on the left, artificial leakage on the right. Experiments on 3.3.2020 & 4.3.2020.

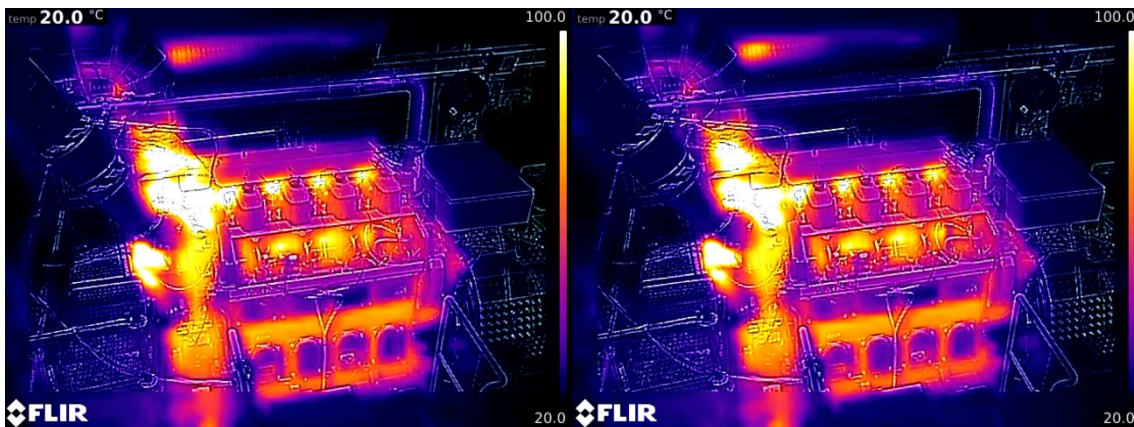
Figure 30. Temperatures at the load command to 100 %. No leakage on the left, artificial leakage on the right. Experiments on 3.3.2020 & 4.3.2020.
