Vibration Analysis of Aviation Electric Propulsion Test Stand with Active Main Rotor

This paper focuses on the vibration analysis of a prototype helicopter rotor test stand, with particular attention to the dynamic response of its electric propulsion system. The stand is driven by an induction motor and equipped with composite rotor blades of various geometries, including blades with shape memory alloy (SMA)-based torsion actuators for angle of attack (AoA) adjustment. These variable geometries significantly influence the system's dynamic behavior, where resonance phenomena may pose risks to structural integrity. The objective was to investigate how selected operational parameters specifically motor speed and AoA affect the vibration response of the propulsion system. Structural vibrations were measured using a tri-axial piezoelectric accelerometer system integrated with calibrated signal conditioning and high-resolution data acquisition modules. This setup enabled precise, time-synchronized recording of dynamic responses along all three axes. Fast Fourier Transform (FFT) and Power Spectral Density (PSD) methods were applied to identify dominant frequency components, including tho

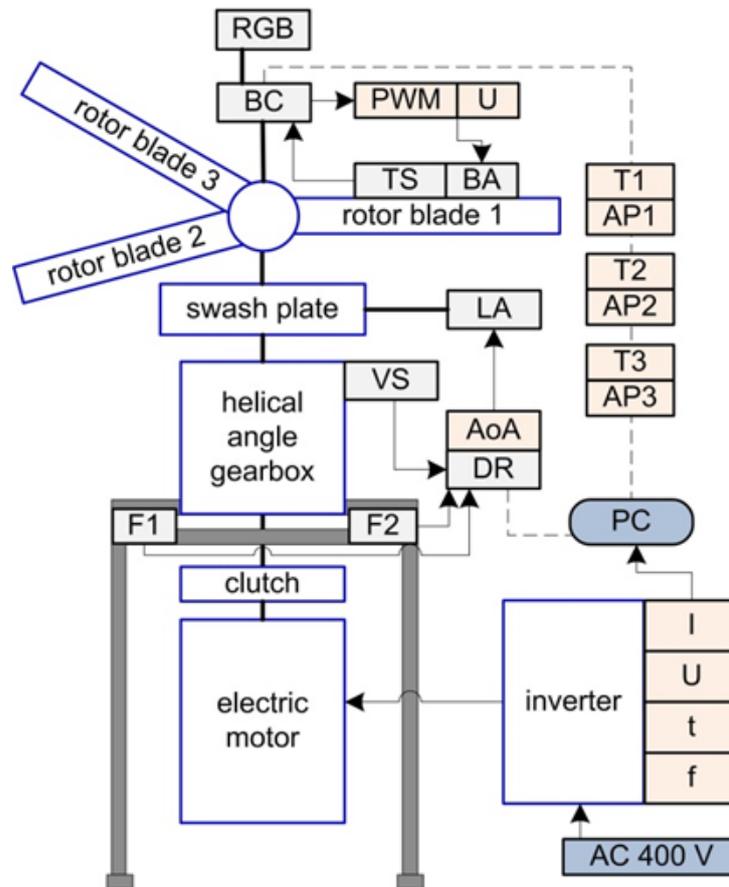
Figure 1. General scheme of the test stand, BC—blade controller, RGB—color signaling of status, TS—temperature sensor, BA—blade actuator, LA—linear actuator, VS—three axis vibration sensor, DR—data recorder, F1, F2—tensometer, T1–T3—temperature in blade, AP1–AP3—actuator position, AoA—angle of attack, PWM—actuator power signal filling, U—voltage, I—current, t—time, f—frequency. The arrows indicate the directions of the signal and the electric supply.

The test stand presented on Figure 1 is powered by a three-phase electric motor, with its voltage and current regulated by an inverter connected to the power grid. The operator can smoothly adjust the motor shaft speed at every test stage and can perform an emergency stop using a safety button. The electric motor drives the helicopter's main gearbox via a clutch, which is connected to a rotor equipped with a swashplate. Prototype collective blades were mounted on the rotor. During testing, a range of parameters was recorded, including platform vibrations along the X, Y, and Z axes, lift force generated by the blades, and operating parameters of the SMA actuators. All data were continuously logged on a PC.

The test stand is powered by an electric motor operating at 1500 rpm. Vibration isolation of the test stand relative to the ground was ensured by placing the structure on four BSL 08012 isolators (MULTI Wyroby Gumowe, Jugowice, Poland). The shaft velocity is variably adjusted via the inverter control panel, and measurement data are transmitted to the PC using an RS485-USB converter. Detailed technical parameters are listed in Table 1.

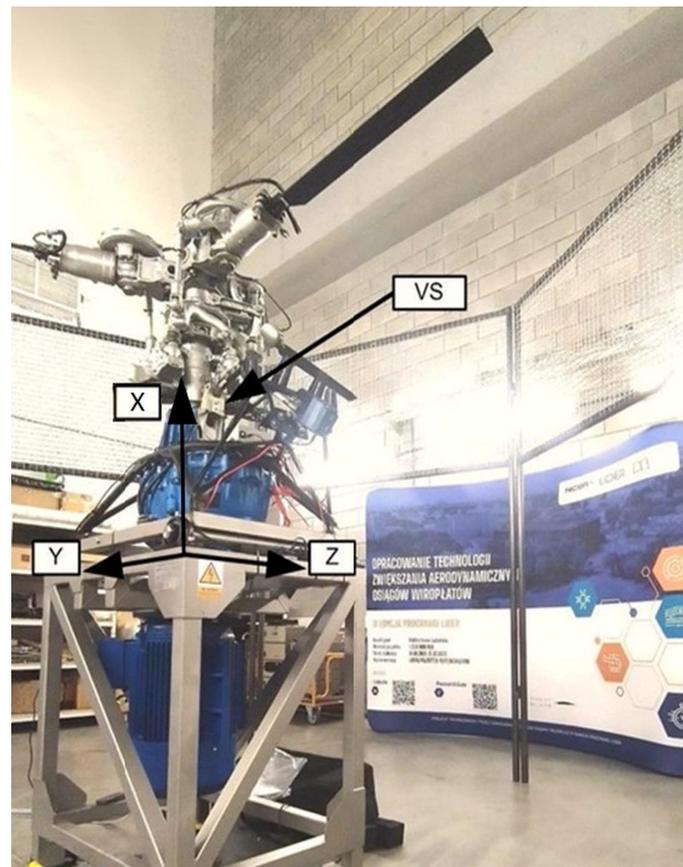
Figure 2. Axis and vibration sensors (VS) on the test stand.

Figure 2 indicates that the test stand enables vibration measurements in the X, Y, and Z axes. These axes were selected due to the lift force acting along the X-axis, while most rotating components move in the Y–Z plane. The stand is equipped with a specialized system for recording vibration waveforms. Vibration sensors were mounted at the top of the main gearbox housing and shown on Figure 3.

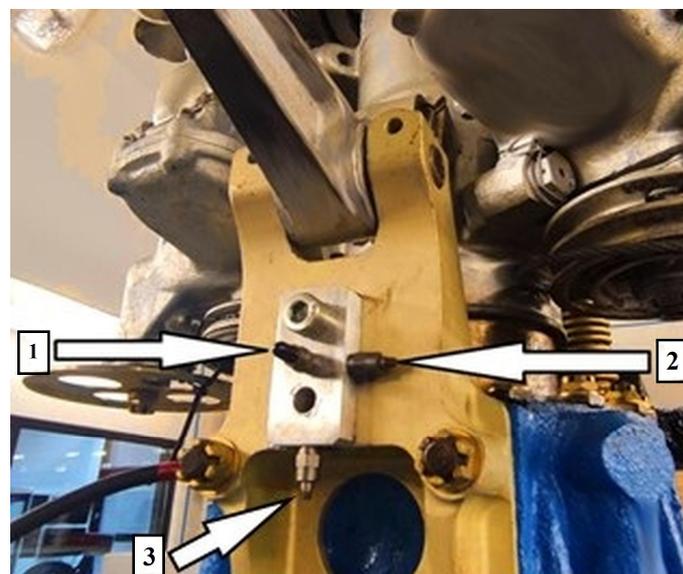
Figure 3. Placement of vibration sensors on the main gearbox: 1: Y-axis, 2: Z-axis, 3: X-axis.

1. A set of three piezoelectric vibration sensors M353B12 (PCB Piezotronics, Depew, NY, USA), showed in Figure 3, was used to record vibrations along all axes. The transverse sensitivity and nonlinearity of these sensors ensure accurate acquisition of dynamic responses across the frequency bands relevant to rotorcraft test stands.
2. Signal conditioning was performed using the VibAMPPA-3000 (EC Electronics Ltd., Basingstoke, United Kingdom) charge amplifier, which provided charge-to-voltage

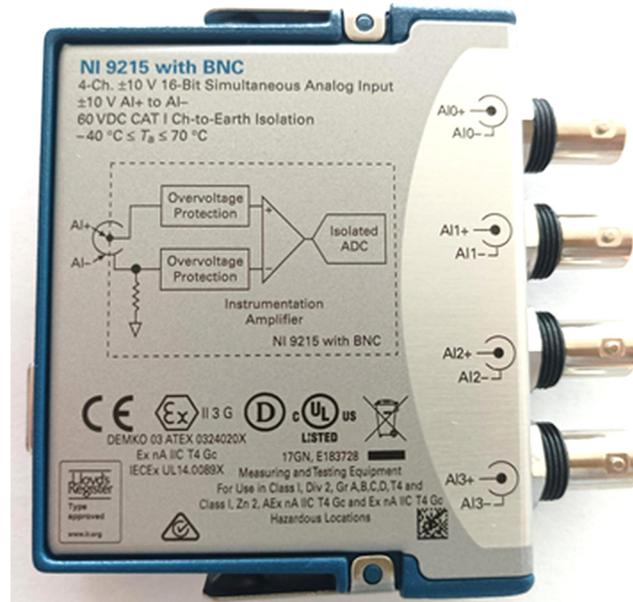
Figure 4. NI-9215 measuring card.

3. Signal acquisition was performed using the NI-9215 C-Series (National Instruments, Austin, TX, USA) analog input module (Figure 4), equipped with four simultaneously sampled differential input channels.

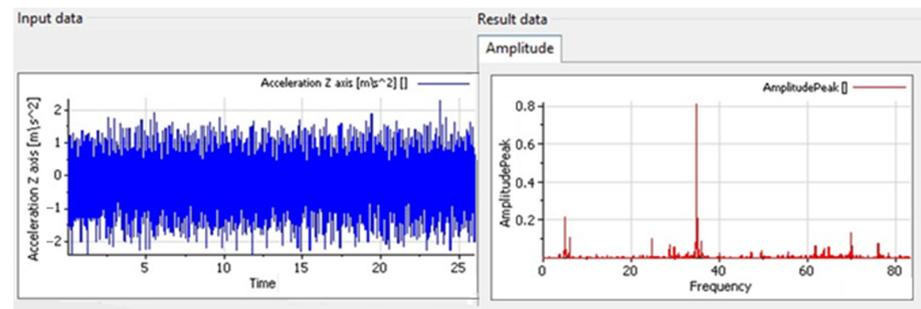
Figure 5. NI DIAdem 2023 Q2 software operational window.

The data underwent preliminary preprocessing before being imported into the NI DIAdem environment (Figure 5). Spectral analysis was performed using Fast Fourier Transform (FFT), which made it possible to obtain vibration spectra characteristic of the tested stand [34].

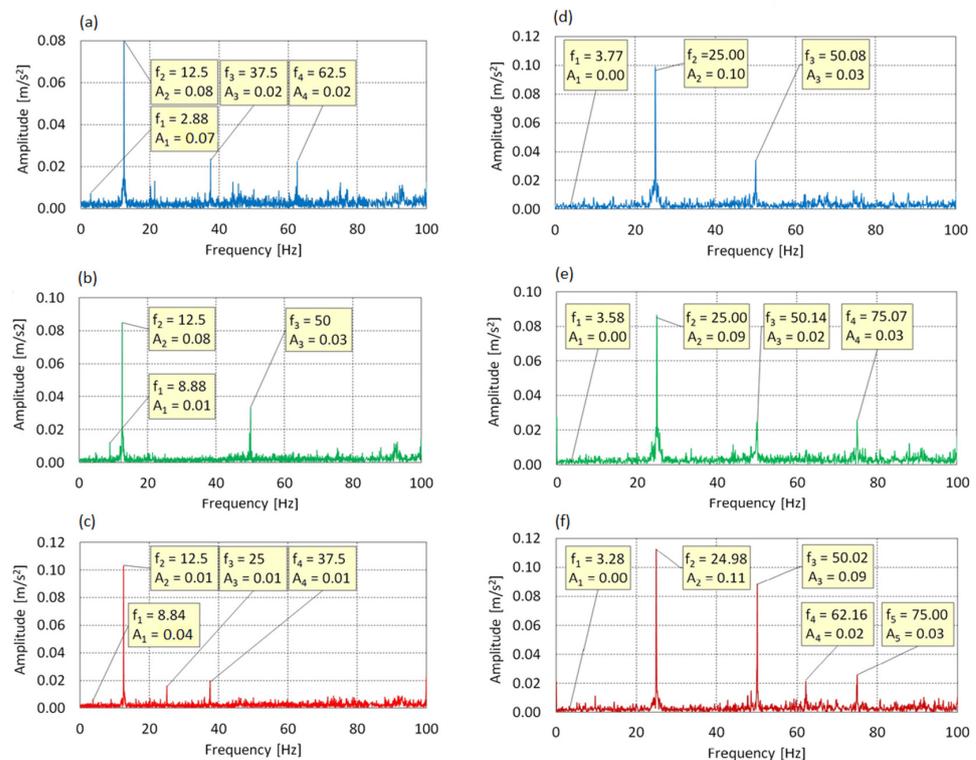
Figure 6. Vibration spectrum for the $f_0 = 25$ Hz: (a) AoA = 0° , X-axis; (b) AoA = 8° , X-axis; (c) AoA = 16° , X-axis; (d) AoA = 0° , Y-axis; (e) AoA = 8° , Y-axis; (f) AoA = 16° , Y-axis.

Figures 6 and 7 present the vibration spectra along the X, Y, and Z axes at a motor shaft speed of $f_0 = 25$ Hz. The variable parameter was the blade angle of attack. The charts illustrate prominent peaks corresponding to the fundamental and harmonic frequencies of the drive shaft ($f_0 = 25$ Hz) and the swashplate. A linear scale was chosen for the all FFT spectra to clearly display all significant frequency components without masking lower-amplitude peaks.

In the spectrum shown in Figure 6, four dominant components were identified: $f_1 = 2.88$ Hz, $f_2 = 12.5$ Hz, $f_3 = 37.5$ Hz, and $f_4 = 62.5$ Hz. The frequency f_1 corresponds to the actual rotational speed of the main rotor, resulting from gear reduction ($f_0 = 25$ Hz) with a ratio of 8.68:1. The highest amplitude (0.08 m/s^2) occurred at $f_2 = 12.5$ Hz, which is a subharmonic ($0.5 \times f_0$). The presence of components f_3 and f_4 , corresponding to $1.5 \times$ and $2.5 \times f_0$, indicates that the vibration spectra exhibit a rich frequency content with multiple harmonic and sub-harmonic components, reflecting the multi-source excitation of the test stand. The absence of a peak at $f_0 = 25$ Hz suggests selective damping of the fundamental excitation and dominance of subharmonic resonance.

At $AoA = 8^\circ$, the spectral structure changes—three main components appear: $f_1 = 8.88$ Hz, $f_2 = 12.5$ Hz, and $f_3 = 50$ Hz. The frequency f_1 may result from cyclic excitation of the three-bladed rotor. The presence of harmonics and a clear peak at 50 Hz indicates intensified dynamic activity due to increased aerodynamic loading.

At $AoA = 16^\circ$, the spectrum becomes further dispersed four peaks are visible: $f_1 = 8.84$ Hz, $f_2 = 12.48$ Hz, $f_3 = 25$ Hz, and $f_4 = 37.5$ Hz. Amplitudes are relatively even, suggesting a transition from a subharmonic to a more harmonic system response, with a uniform distribution of energy among primary and secondary components.

Changes in the spectral structure with increasing AoA can be interpreted as an effect of growing aerodynamic loads. Excitation at approximately $3 \times f_{rotor}$ may be attributed to asymmetrical blade loading. Such frequency distributions are typical for systems with dynamic coupling between aerodynamic forces and structural response.

In the Y-axis spectrum, three dominant components were observed: $f_1 = 3.77$ Hz, $f_2 = 25$ Hz, and $f_3 = 50$ Hz. The component f_1 corresponds to rotor rotation but has minimal amplitude and does not significantly affect the dynamic response. The main energy is

concentrated at $f_2 = 25$ Hz (drive frequency), indicating direct energy transfer from the propulsion system to the structure. The component $f_3 = 2 \times f_0$ is likely due to asymmetric excitation or nonlinear structural deformations.

The highest amplitude (0.10 m/s^2) was recorded at $f_3 = 25$ Hz. The absence of subharmonics and minimal contribution from higher harmonics suggests a harmonic and linear system response at $\text{AoA} = 0^\circ$.

At $\text{AoA} = 8^\circ$, the spectral structure broadens $f_4 = 75.07$ Hz ($3 \times f_0$) appears, along with a slight increase at $f_3 = 50.14$ Hz. The presence of a third harmonic reflects growing system nonlinearity due to increased aerodynamic forces. Nevertheless, $f_2 = 25$ Hz remains dominant, indicating a quasi-harmonic response.

At $\text{AoA} = 16^\circ$, the spectrum becomes more complex besides f_2 and its harmonics, a new component $f_4 = 62.16$ Hz emerges, not being a multiple of f_0 . This may indicate local resonances or internal modal coupling. The increased amplitude of f_3 relative to f_2 suggests intensifying nonlinear behavior under full aerodynamic loading.

Since vibrations along the Y-axis occur in the rotor plane, the observed increase in harmonic content and additional components with growing AoA is associated with increased lateral forces and complex structural responses due to unsteady aerodynamic conditions. The spectral peaks presented on Figures 6–11 are classified based on their order dependence on shaft speed and gearbox ratio, allowing us to distinguish between drive-related and rotor-related harmonics.

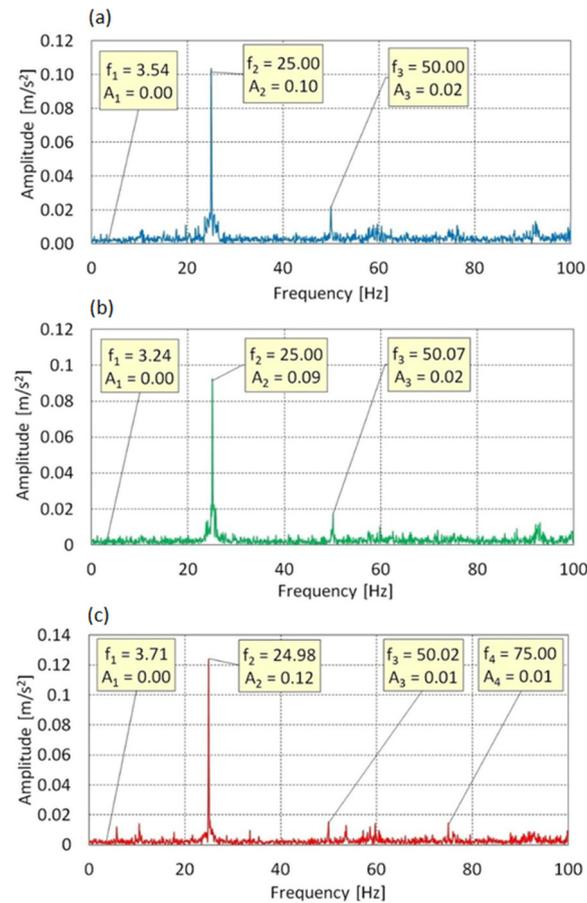
Figure 7. Vibration spectrum for the $f_0 = 25$ Hz in Z-axis: (a) $AoA = 0^\circ$, (b) $AoA = 8^\circ$, (c) $AoA = 16^\circ$.

Figure 7 presents the vibration spectra along the Z-axis. Three dominant components were identified: $f_1 = 3.54$ Hz, $f_2 = 25.00$ Hz, and $f_3 = 50.00$ Hz. Component f_1 , associated with rotor rotation, showed minimal amplitude and did not significantly influence the dynamic response. The dominant component was $f_2 = 25$ Hz (f_0) with a maximum amplitude of 0.10 m/s², while $f_3 = 2 \times f_0$ had a much lower amplitude (0.02 m/s²), suggesting weak nonlinearities or asymmetric loads.

The lack of subharmonics and suppression of higher harmonics confirm the harmonic nature of vibrations at $\text{AoA} = 0^\circ$. At $\text{AoA} = 8^\circ$, the spectral structure remains largely unchanged f_0 still dominates, and the influence of higher harmonics is negligible. Small frequency shifts may result from signal nonstationarity or sampling limitations.

At $\text{AoA} = 16^\circ$, an additional component $f_4 = 75.00$ Hz ($3 \times f_0$) appears, but its amplitude remains low. Dominance of $f_2 = 24.98$ Hz is preserved, confirming a stable dynamic response. The increase in higher harmonic amplitudes may signal early signs of nonlinearity, but does not conclusively indicate structural resonances.

Vibrations in the Z-axis lying in the rotor plane, are primarily induced by mechanical drive excitation. The spectral characteristics remain stable and linear, even under full aerodynamic loading.

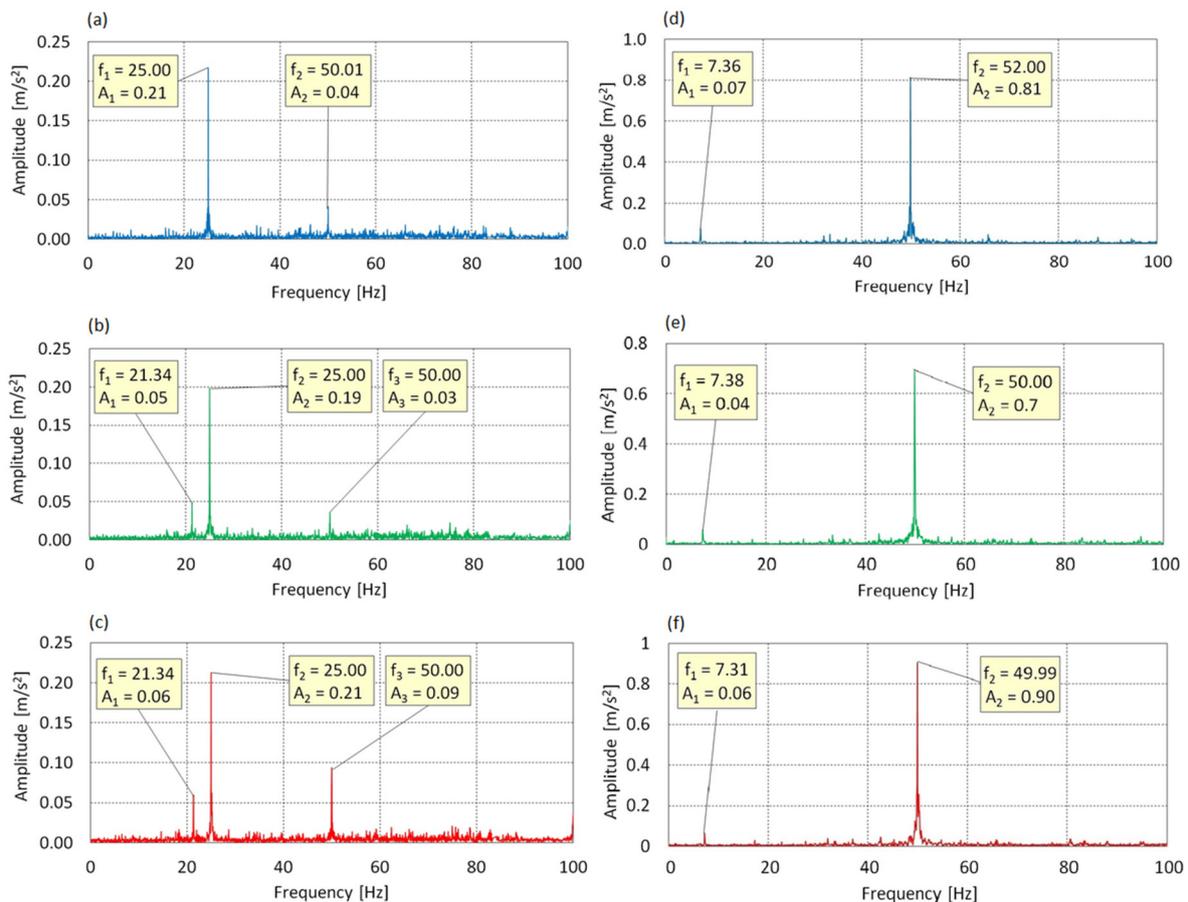
Figure 8. Vibration spectrum for the $f_0 = 50$ Hz: (a) $\text{AoA} = 0^\circ$, X-axis; (b) $\text{AoA} = 8^\circ$, X-axis; (c) $\text{AoA} = 16^\circ$, X-axis; (d) $\text{AoA} = 0^\circ$, Y-axis; (e) $\text{AoA} = 8^\circ$, Y-axis; (f) $\text{AoA} = 16^\circ$, Y-axis.

Figures 8 and 9 presents the vibration spectra of the test stand in the X, Y, and Z axes are presented for a rotational speed of the electric motor shaft equal to $f_0 = 50$ Hz.

Figure 8 shows the frequency spectrum for an Angle of Attack of 0° . Two dominant components were identified: $f_1 = 25.00$ Hz ($A_1 = 0.21$ m/s²) and $f_2 = 50.01$ Hz ($A_2 = 0.04$ m/s²). Frequency f_1 , corresponding to $0.5 \times f_0$, exhibits energetic dominance, indicating the presence of subharmonic dynamic excitation. The relatively low amplitude of f_2 ($1 \times f_0$) may suggest a nonlinear system response, potentially resulting from gearbox backlash or excitation asymmetry.

At $\text{AoA} = 8^\circ$, the spectrum expands to include an additional component $f_1 = 21.34$ Hz ($A_1 = 0.05$ m/s²), which may indicate modal resonance. Frequency $f_2 = 25$ Hz remains dominant, while the contribution of the fundamental harmonic ($f_3 = 50$ Hz) remains limited. The system maintains a subharmonic response profile, accompanied by increased structural activity.

At $\text{AoA} = 16^\circ$, an increase in the amplitude of $f_3 = 50.02$ Hz ($A_3 = 0.09$ m/s²) is observed, while the dominance of $f_2 = 25$ Hz is preserved. The persistence of component $f_1 = 21.34$ Hz indicates continued dynamic coupling, and the elevated activity at $1 \times f_0$ is likely a result of full aerodynamic blade loading.

Vibrations in the X-axis, aligned with the direction of lift, are characterized by a dominant $0.5 \times f_0$ subharmonic and the presence of additional components, which may suggest nonlinear resonance phenomena. The increase in energy at f_0 for higher AoA values is likely due to asymmetric thrust; however, the absence of amplitude escalation rules out the presence of flutter.

At $\text{AoA} = 16^\circ$, the spectrum again consists of $f_1 = 7.31$ Hz and $f_2 = 49.99$ Hz, but a distinct increase in amplitude to $A_2 = 0.90$ m/s² is observed. This may result from intensified driving forces and moments transferred to the structure under full load conditions.

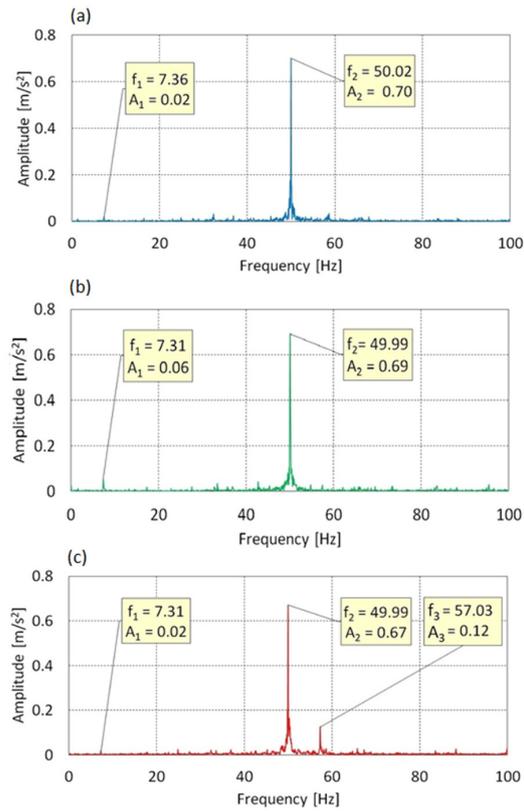
Figure 9. Vibration spectrum for the $f_0 = 50$ Hz in Z-axis: (a) $AoA = 0^\circ$, (b) $AoA = 8^\circ$, (c) $AoA = 16^\circ$.

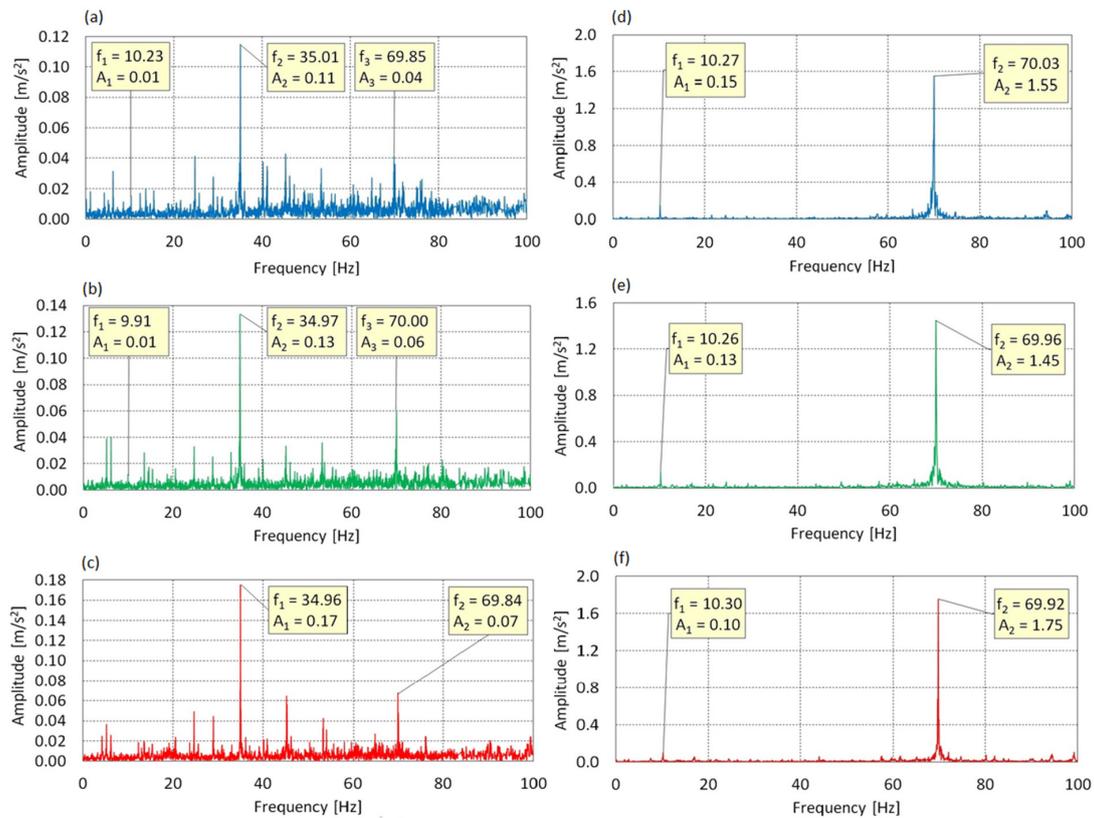
Figure 10. Vibration spectrum for the $f_0 = 70$ Hz: (a) $AoA = 0^\circ$, X-axis; (b) $AoA = 8^\circ$, X-axis; (c) $AoA = 16^\circ$, X-axis; (d) $AoA = 0^\circ$, Y-axis; (e) $AoA = 8^\circ$, Y-axis; (f) $AoA = 16^\circ$, Y-axis.

At $\text{AoA} = 16^\circ$, a similarly complex spectral structure is observed. The most relevant frequencies are: $f_1 = 12.86 \text{ Hz}$, $f_2 = 24.82 \text{ Hz}$, $f_3 = 39.07 \text{ Hz}$, $f_4 = 48.36 \text{ Hz}$, $f_5 = 57.43 \text{ Hz}$, $f_6 = 66.41 \text{ Hz}$. The distribution of frequencies and amplitudes remains irregular, and the dominant peaks do not correlate with f_0 or its harmonics. This may indicate dynamic decoupling of the drive from the structure or the onset of structural instability.

At $\text{AoA} = 16^\circ$, both components are again observed, with a noticeable increase in the amplitude of the main peak: $f_1 = 10.30 \text{ Hz}$, $A_1 = 0.10 \text{ m/s}^2$. The amplitude growth at $f_0 = 70 \text{ Hz}$ may reflect intensified drive-induced vibrations caused by the increasing aerodynamic moment transmitted through the rotor structure under full loading.

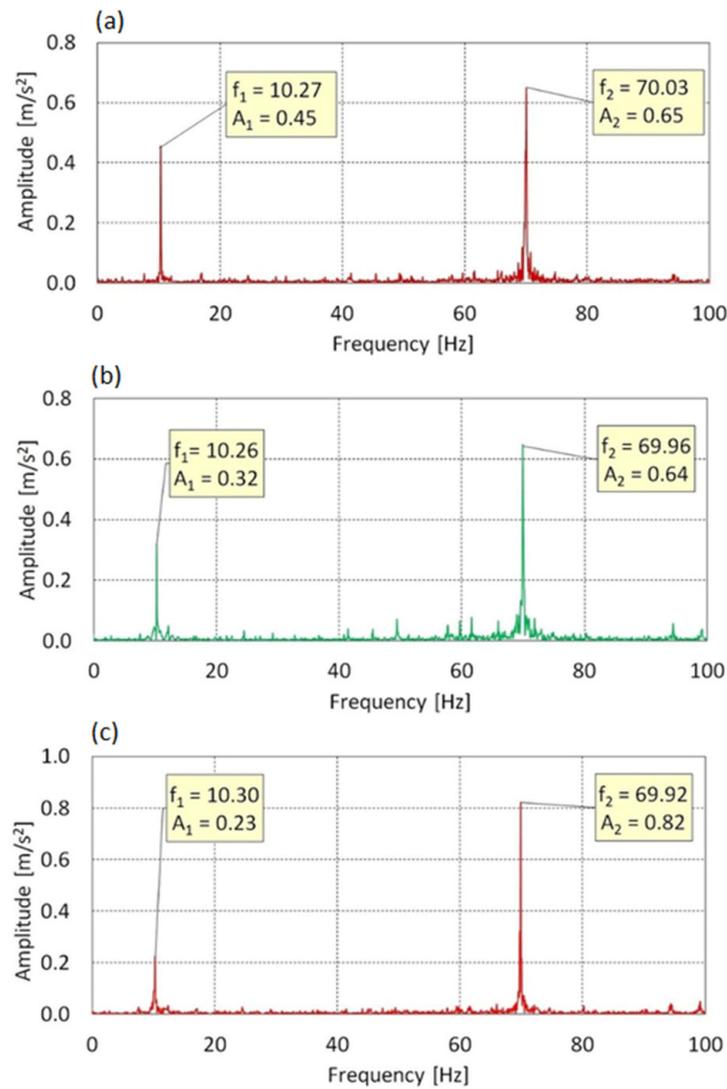
Figure 11. Vibration spectrum for the $f_0 = 70$ Hz in Z-axis: (a) $\text{AoA} = 0^\circ$, (b) $\text{AoA} = 8^\circ$, (c) $\text{AoA} = 16^\circ$.

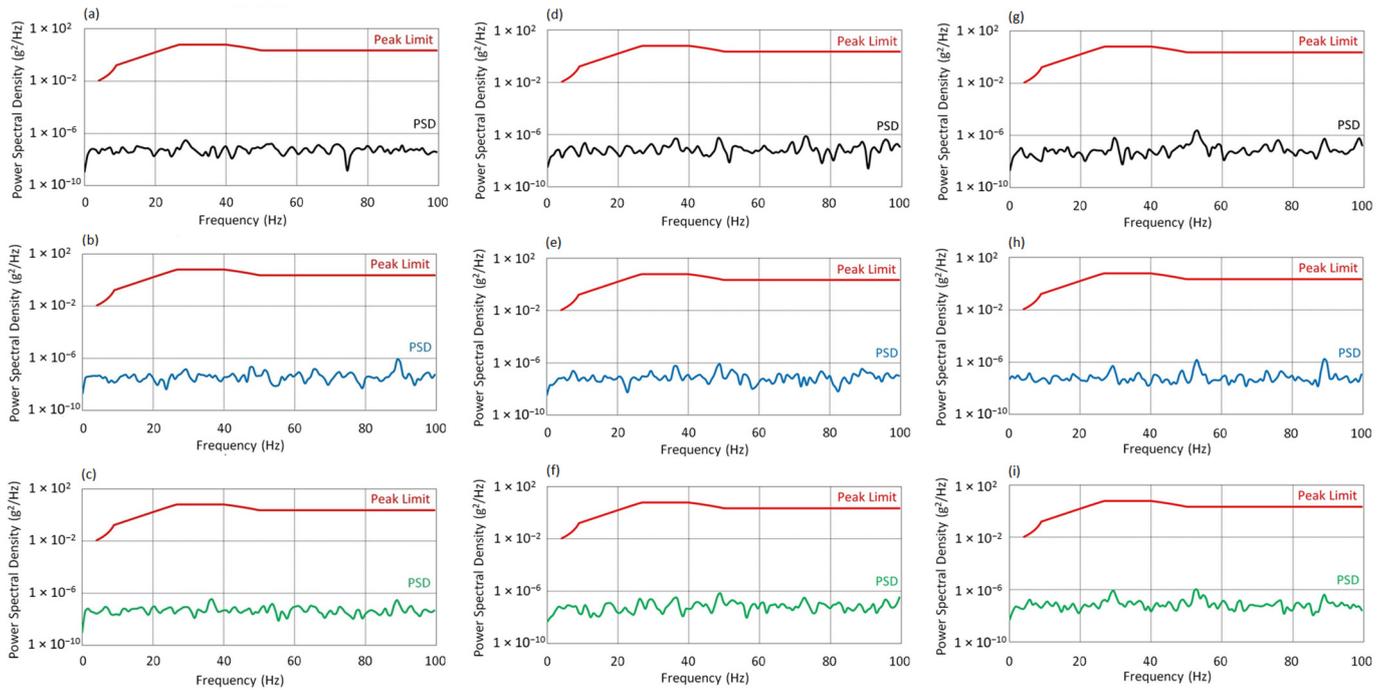
Figure 12. Vibration spectrum for the $f_0 = 25$ Hz: (a) $\text{AoA} = 0^\circ$, X-axis; (b) $\text{AoA} = 8^\circ$, X-axis; (c) $\text{AoA} = 16^\circ$, X-axis; (d) $\text{AoA} = 0^\circ$, Y-axis; (e) $\text{AoA} = 8^\circ$, Y-axis; (f) $\text{AoA} = 16^\circ$, Y-axis; (g) $\text{AoA} = 0^\circ$, Z-axis; (h) $\text{AoA} = 8^\circ$, Z-axis; (i) $\text{AoA} = 16^\circ$, Z-axis.

- At AoA = 0° , moderate vibrations occur within the 10–60 Hz range, with local maxima around 30–40 Hz. However, their amplitudes are significantly lower than the permissible limits. The dynamic response is linear and stable.
- At AoA = 8° , a slight increase in energy is observed in the 20–60 Hz range, along with local enhancements above 80 Hz. Nevertheless, PSD values remain well below the standard threshold, and the system exhibits only moderate dynamic activity without signs of overload.
- At AoA = 16° , the spectral character remains largely unchanged. The vibration levels stabilize across a broad frequency range, and the system maintains a controlled, harmonic operating mode even under full aerodynamic load.

For the Z axis, at $f_0 = 25$ Hz, the PSD spectra remain low in all cases.

- At $\text{AoA} = 0^\circ$, the lowest energy level was recorded absence of significant peaks confirms a well-damped, harmonic system response.
- At $\text{AoA} = 8^\circ$, minor components appear around 55 Hz and 90 Hz, yet their amplitudes remain very low. This may signal the onset of structural activity.
- At $\text{AoA} = 16^\circ$, the spectrum becomes more dispersed, especially above 50 Hz. Despite the increase in PSD levels, the system still meets the standard's criteria, although the intensification of dynamic interactions may warrant further investigation.

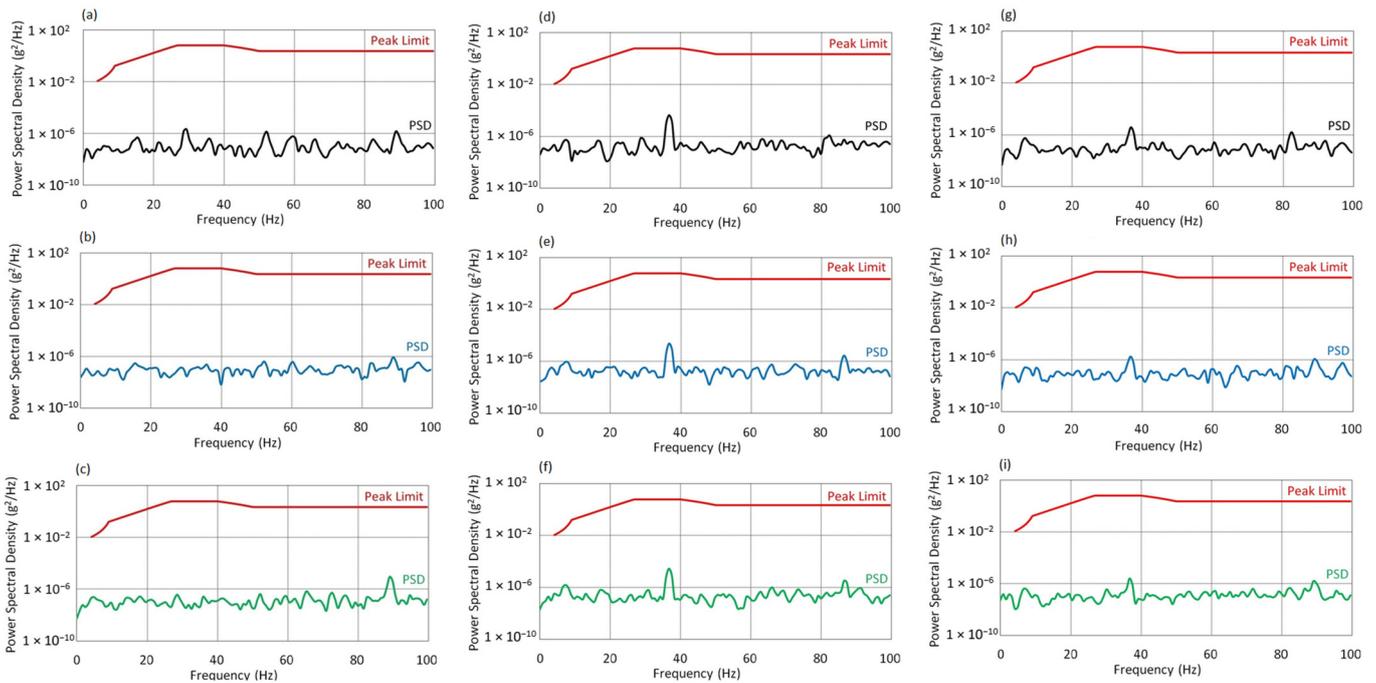
Figure 13. Vibration spectrum for the $f_0 = 50$ Hz: (a) $\text{AoA} = 0^\circ$, X-axis; (b) $\text{AoA} = 8^\circ$, X-axis; (c) $\text{AoA} = 16^\circ$, X-axis; (d) $\text{AoA} = 0^\circ$, Y-axis; (e) $\text{AoA} = 8^\circ$, Y-axis; (f) $\text{AoA} = 16^\circ$, Y-axis; (g) $\text{AoA} = 0^\circ$, Z-axis; (h) $\text{AoA} = 8^\circ$, Z-axis; (i) $\text{AoA} = 16^\circ$, Z-axis.

- At $\text{AoA} = 0^\circ$, the spectrum exhibits a compact structure with local maxima around 30, 55, and 90 Hz. The dynamic response is stable and well-controlled under nominal conditions.
- At $\text{AoA} = 8^\circ$, the spectral range broadens into the 40–80 Hz band. The increase in amplitude around 90 Hz may result from the growing aerodynamic moment; however, PSD values remain safely within limits.
- At $\text{AoA} = 16^\circ$, the spectrum becomes the most developed. The most noticeable amplitude increase is again observed near 90 Hz, which may indicate the activation of additional structural modes under full aerodynamic load. Despite this, vibration levels remain below critical thresholds.

For the Y axis at $f_0 = 50$ Hz, the system exhibits characteristic dynamic behavior with increasing AoA .

- At $\text{AoA} = 0^\circ$, a pronounced maximum appears in the 35–40 Hz band, with a dominant peak around ~ 37 Hz, reaching values exceeding $1 \times 10^{-6} \text{ g}^2/\text{Hz}$. Despite this localized intensification, the amplitude remains below the standard's threshold.
- At $\text{AoA} = 8^\circ$, the energy level in this range slightly decreases. This may be interpreted as the result of minor damping due to altered aerodynamic conditions or redistribution of forces within the structure.
- At $\text{AoA} = 16^\circ$, no further changes in spectral distribution are observed. The consistent amplitude level suggests stable resonance conditions, regardless of increased angle of attack.

For the Z axis at $f_0 = 50$ Hz, the main vibration energy is concentrated in the 30–40 Hz and 90–100 Hz bands, with a dominant peak in the 36–37 Hz region.

- At $\text{AoA} = 0^\circ$, the amplitudes are highest but maintain a clear margin below the MIL-STD threshold.
- As the angle of attack increases ($\text{AoA} = 8^\circ$ and 16°), a systematic decrease in PSD levels is observed both in the resonance region and across the entire analyzed spectrum. This may indicate increased system stiffness or a change in vibration propagation conditions under higher aerodynamic loads.
- In all cases, the dynamic response in the Z-axis remains safe and shows no signs of exceeding acceptable vibration levels.

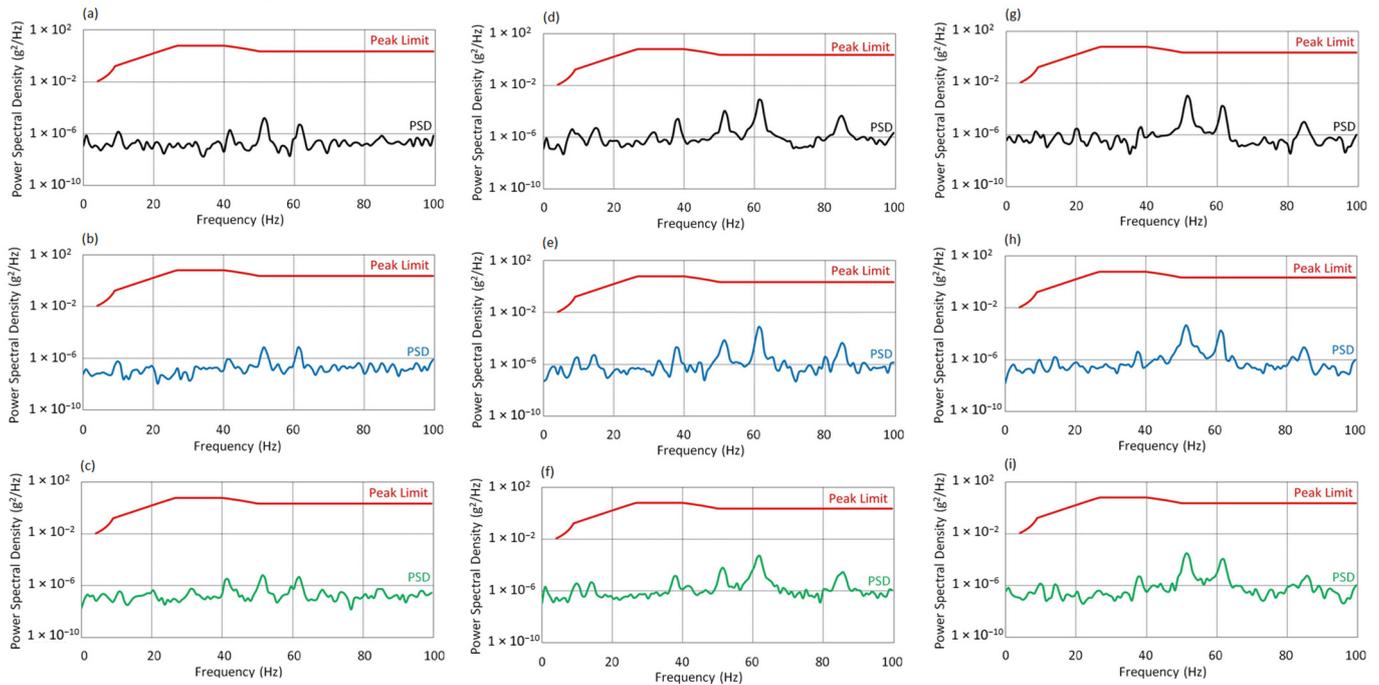
Figure 14. Vibration spectrum for the $f_0 = 70$ Hz: (a) AoA = 0° , X-axis; (b) AoA = 8° , X-axis; (c) AoA = 16° , X-axis; (d) AoA = 0° , Y-axis; (e) AoA = 8° , Y-axis; (f) AoA = 16° , Y-axis; (g) AoA = 0° , Z-axis; (h) AoA = 8° , Z-axis; (i) AoA = 16° , Z-axis.

Figure 14 presents the Power Spectral Density spectra for the X, Y, and Z axes at an excitation frequency of $f_0 = 70$ Hz, for three angles of attack. For the X axis at $f_0 = 70$ Hz, in contrast to lower rotational speeds, dominant PSD amplifications occur in the 50–60 Hz range. The presence of two distinct peaks may indicate neighboring resonance frequencies, suggesting a complex modal structure of the system.

- At AoA = 0° , the PSD values remain well below the standard's threshold.
- At AoA = 8° , a moderate decrease in amplitude is observed, whereas at AoA = 16° , the spectrum becomes more dispersed, and local maxima are further attenuated. This may indicate increased damping or a favorable shift in the system's dynamic characteristics. Despite the presence of secondary resonances, the overall PSD remains within the MIL-STD-810H limits.

For the Y axis, at the same excitation frequency ($f_0 = 70$ Hz), three main peaks are observed in the 38–62 Hz range.

- At AoA = 0° , the dominant component occurs at 62 Hz, which may result from structural resonance excitation or secondary effects from the drive system. The spectral profile suggests significant energy interaction near the f_0 frequency. Although the harmonic structure is denser, amplitudes remain below threshold values.
- At AoA = 8° , the main components remain within the same frequency intervals, confirming the stability of the dynamic response.
- At AoA = 16° , a noticeable increase in PSD is observed in the 30–50 Hz band, indicating intensified energy transfer from the drive to the structure. The spectrum becomes more dispersed, yet remains within the limits defined by the standard.

- At AoA = 8° , the spectral characteristics are similar, though shifts and densification of components in the 55–65 Hz range are visible. This may result from a varying distribution of centrifugal and aerodynamic forces.
- At AoA = 16° , an amplitude increase is observed around 70 Hz, and the spectrum becomes more complex. The appearance of minor peaks above 80 Hz may indicate the
